BULLETIN No. 510

TIMBER STORAGE CONDITIONS IN THE EASTERN AND SOUTHERN STATES WITH REFERENCE TO DECAY PROBLEMS.

By C. J. HUMPHREY, *Pathologist, Office of Investigations in Forest Pathology.*

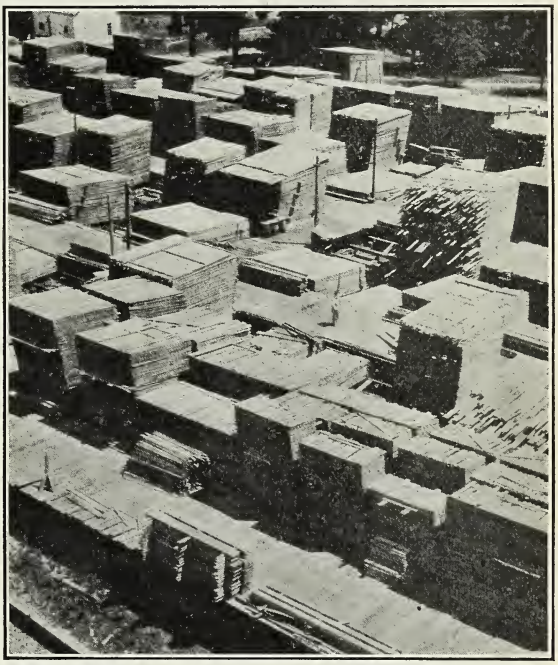
FIG. 1.—Bird's-eye view of a clean lumber-mill yard in Arkansas, showing the usual method of open storage.

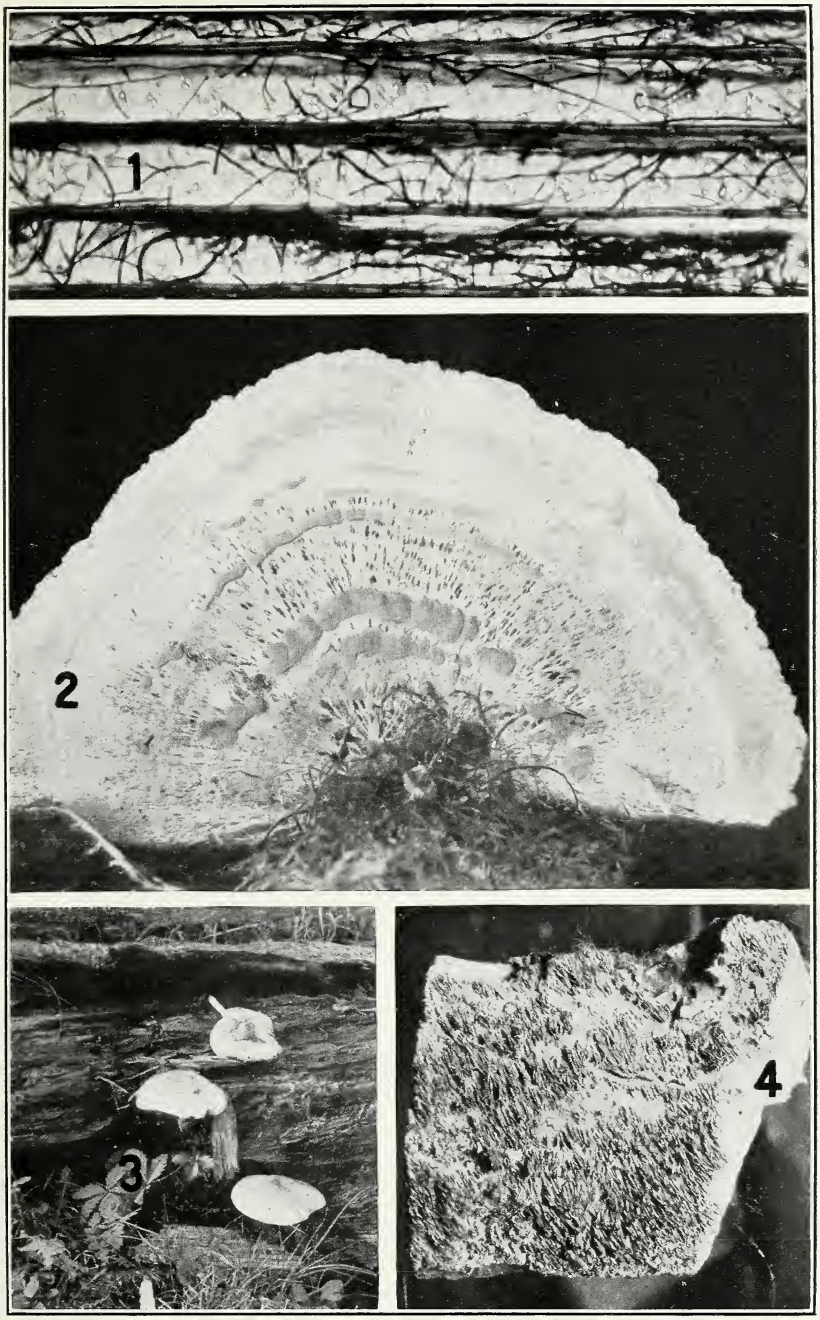
LUMBER SANITATION: WOOD-ROTTING FUNGI.—I.

FIG. 1.—Thin section of "red-heart" pine, showing fungous threads and holes where these have bored through the walls of the wood cells. FIG. 2.—Mycelium on a board from a clay mine, Joplin, Mo. FIG. 3.—The mushroom *Pluteus cervinus* on a rotten log. FIG. 4.—A species of Hydnum.

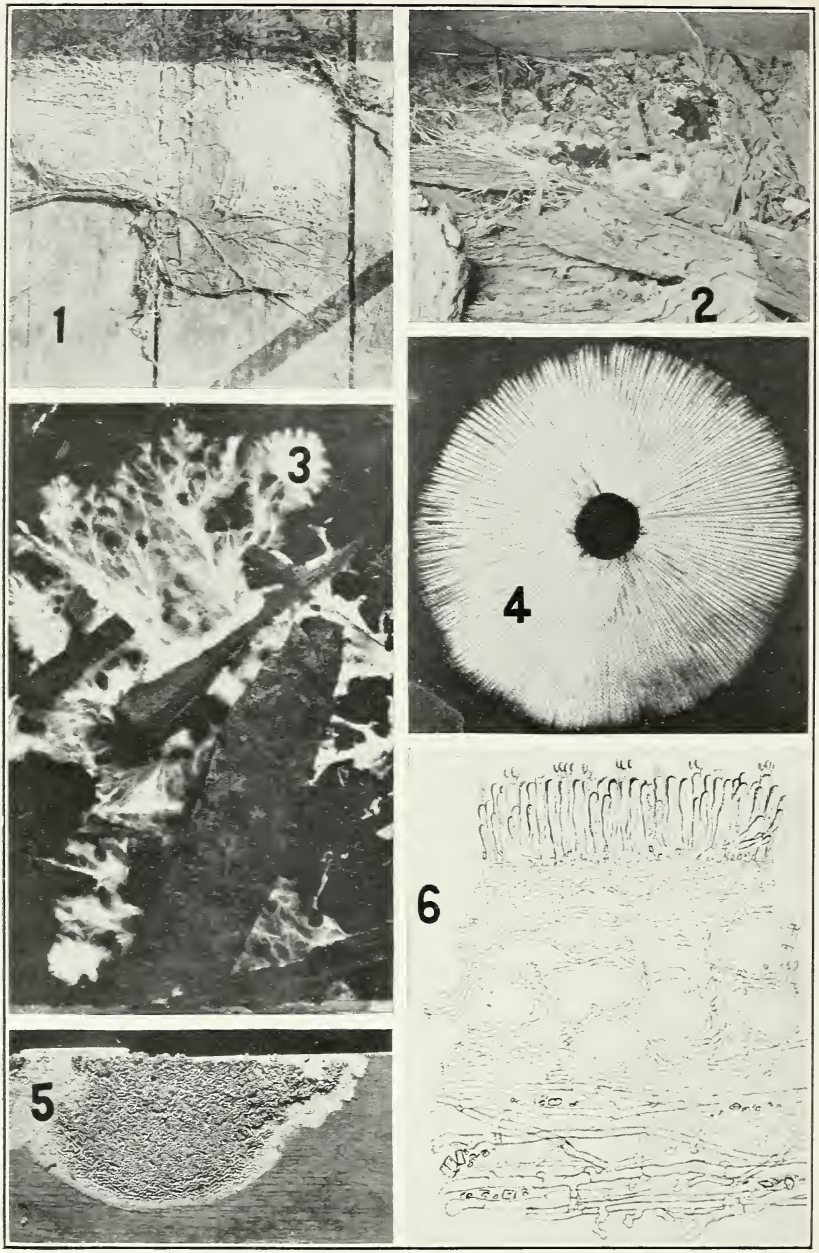
LUMBER SANITATION: WOOD-ROTTING FUNGI.—II.

thus passed during rainy weather from the bottom upward through piles 12 to 15 feet high. In lumber storage sheds or in the base of close piles the mycelium of several species of fungi has frequently been observed developing in great abundance, not alone on the moist foundations and lower layers of lumber (Pl. II, fig. 1), but also spreading profusely on the soil (Pl. II, figs. 2 and 3).

FIG. 1.—Strands of mycelium of the "dry-rot" fungus, *Merulius lachrymans*, on the face of pine planks in a lumber pile at Portland, Me. (the fungus has progressed to a height of six layers or more). FIG. 2.—The same fungus on the ground and in litter beneath an open storage shed, Philadelphia, Pa. FIG. 3.—Mycelium of a white Poria on the ground and on wood fragments beneath a cotton mill, Adams, Mass. FIG. 4.—Powdery deposit of spores cast by a mushroom over night (after Atkinson). FIG. 5.—A species of Poria from a porch ceiling, Madison, Wis. FIG. 6.—Thin section of an encrusting fruit body of *Merulius lachrymans*, showing palisade layer of basidia bearing spores (after Falck).

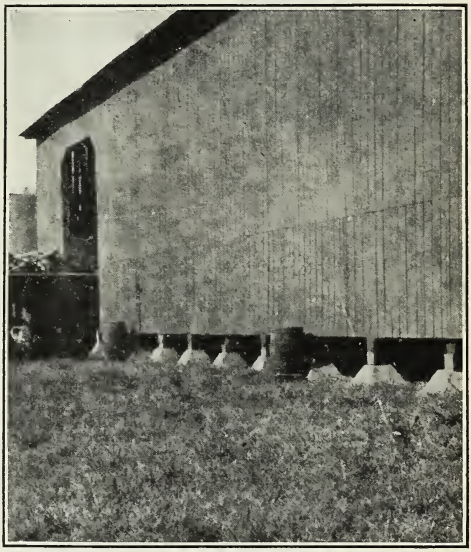
FIG. 6.—Large storage shed at Laurel, Miss., set on concrete piers, high off the ground, with ample ventilation from all sides. This is the best type of construction.

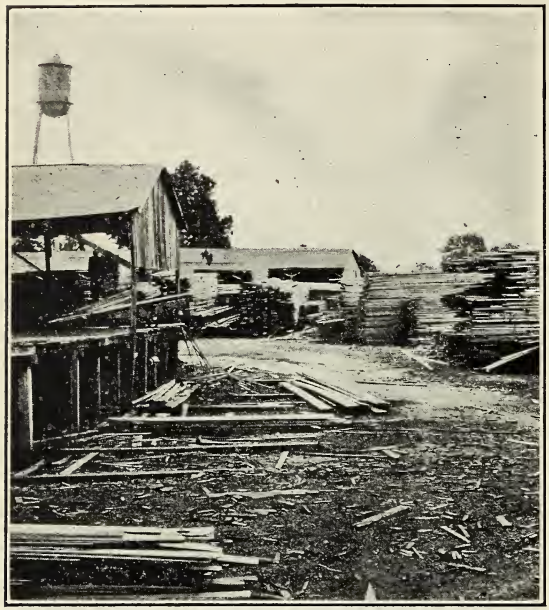
FIG. 7.—A small, very insanitary mill in Louisiana. The conditions at this mill are a disgrace to the lumber industry. Note the rotten, dilapidated tramway, the lumber stacks placed within 2 to 4 inches of the ground, and the débris scattered about and breeding infection.

Any decaying timber which has been allowed to accumulate about the yards should be collected and burned. The mere carting of such débris to a convenient near-by pile (Pl. III, fig. 1; text fig. 9) is not sufficient, for the fungi will continue to thrive in such material for long periods and to produce fruit bodies which will liberate millions upon millions of spores into

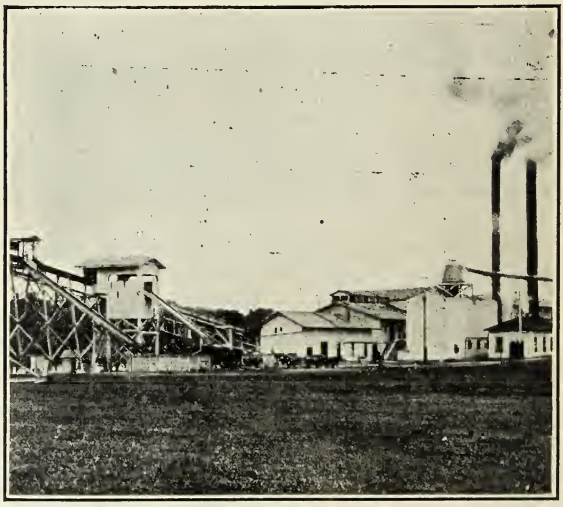
FIG. 8.—The well-kept grounds of a high-class longleaf-pine mill in Louisiana. Practically all the lumber is run through the dry kiln and stored in large sheds, thus eliminating the problem of storage rots.

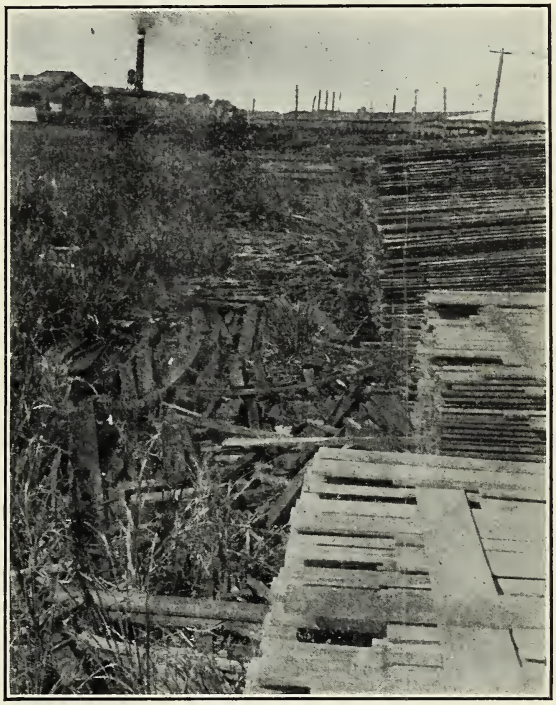
FIG. 9.—Pine and hardwood lumber which has rotted in storage in the yard shown in figure 11. Instead of burning the débris it was thrown into an adjoining rice swamp. Fungi developing on this débris will again infect the sound lumber.

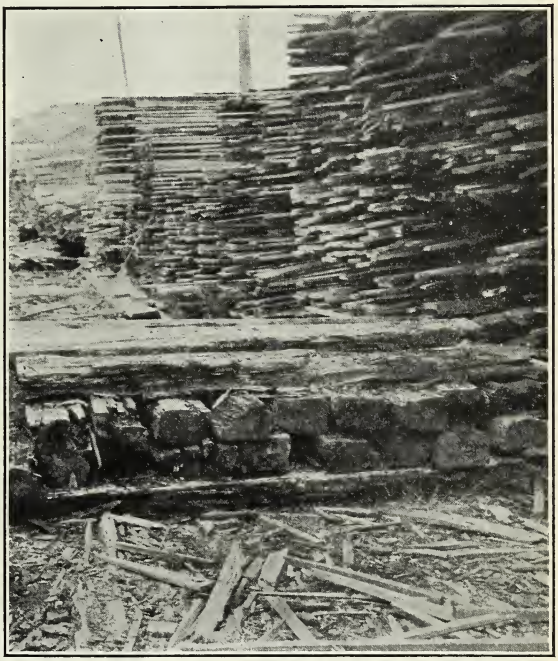
the air to infect whatever sound lumber may be in the vicinity. The writer has seen scores of instances where small piles of rotting débris have been scattered about lumberyards and even at times piled directly against sound lumber (fig. 10). Very frequently this débris consists of old ties (fig. 11) or timbers from the tramway platforms. In other cases it may be yard stock which has rotted in storage and has been left in situ or carted a few rods and discarded just beyond the confines of the yard. One such mill yard was visited where several hundred thousand feet of pine and hardwood lumber had been thrown into an adjoining rice swamp in close proximity to and extending for nearly a mile along a row of lumber stacks (see fig. 9). In this same yard it was also commonly noted that sound lumber fresh from the saw was piled upon the bases of old lumber piles which were thoroughly rotted (fig. 12).

FIG. 11.—A highly insanitary mill yard in South Carolina. Hundreds of thousands of feet of stored lumber have rotted in this yard as a result of these conditions. All this rotten débris should be removed and burned.

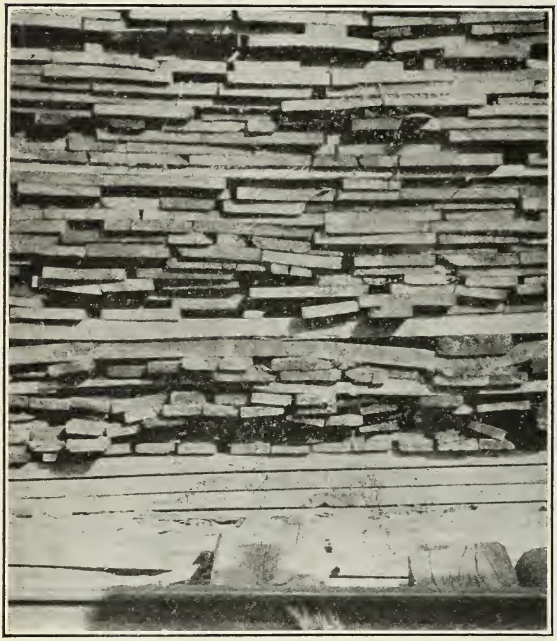
FIG. 12.—Rotten base of an old hardwood stack upon which sound lumber has been piled. This is a most insanitary practice, as fungous infection will be spread both by the contact of the diseased with the sound lumber and indirectly by the production of fruit bodies and spores, the latter blowing about, reaching sound material, and germinating to produce new infections.

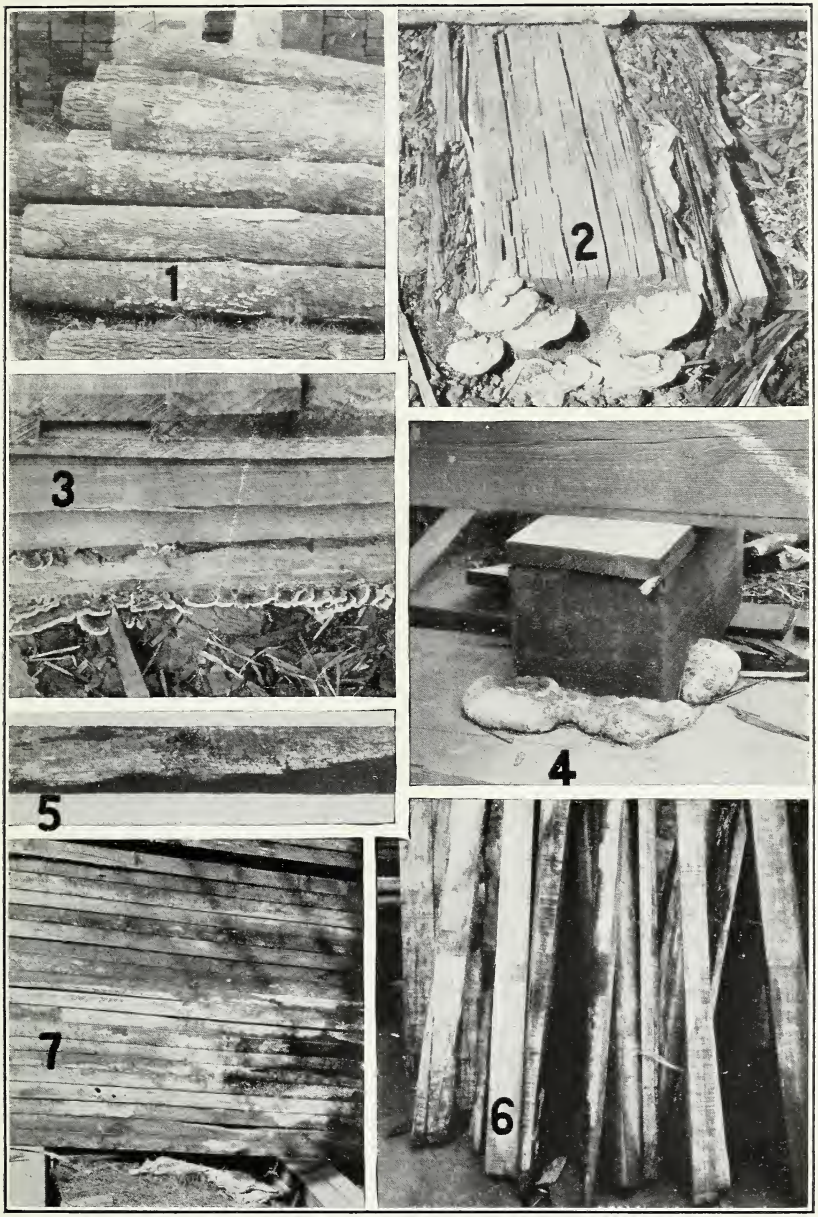
LUMBER SANITATION: WOOD-ROTTING FUNGI.—III.

FIG. 1.—A pile of rejected hardwood logs which should have been removed or destroyed and not left to breed fungi (fruit bodies of 6 or 7 different organisms were identified from this pile). FIG. 2.—*Lenzites berkeleyi* fruiting on a hardwood tie. FIG. 3.—Hardwood pile foundations severely infected with *Polystictus versicolor*. FIG. 4.—*Daedalea quercina* fruiting around a foundation block in a Pennsylvania storage yard. FIG. 5.—A badly infected piling stick in use at a Florida mill. FIG. 6.—A group of infected piling sticks at a Tennessee hardwood mill. FIG. 7.—Pile of 3-inch hard pine planks badly infected with *Peniophora gigantea* (a very common condition at Portland, Me.; the fungus is introduced from the South and develops rapidly in close piles).

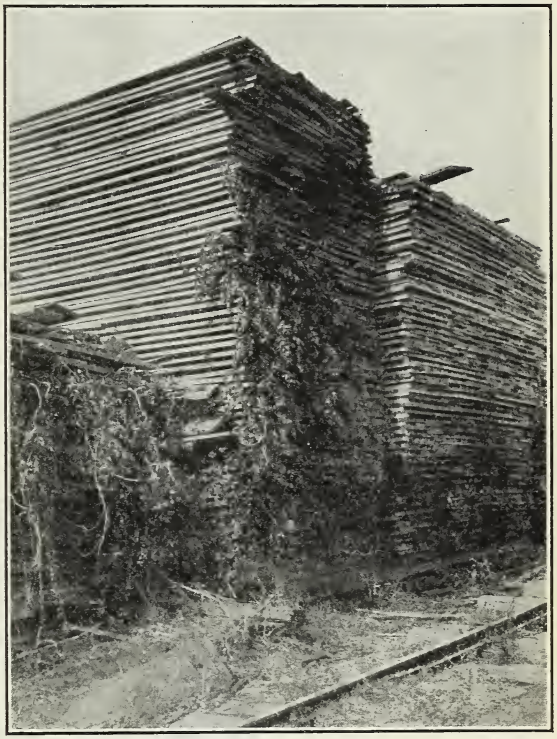
Also in this yard, as well as in a yard in Mississippi, vines were allowed to grow up over some of the lumber piles (fig. 13). This is, of course, highly objectionable, since such vegetation tends to collect moisture and impedes ventilation.

FIG. 13.—Vines growing over lumber piles. From a pathological standpoint this condition should be condemned, because the dense foliage prevents the lumber from rapidly drying out after rains, thus promoting decay.

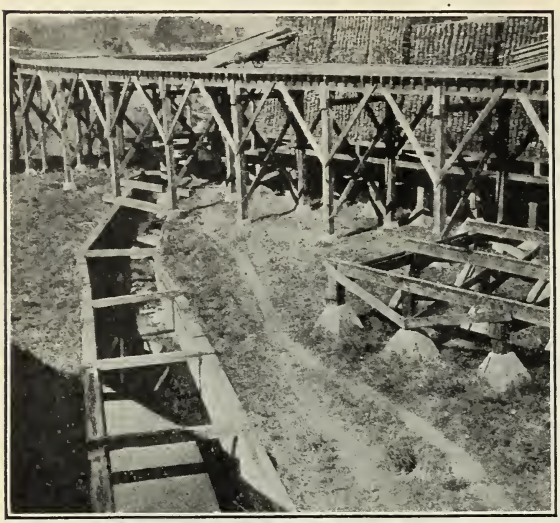
Foundations with concrete piers and untreated skids are at present in use in a number of yards and have given entire satisfaction. At one Mississippi mill (figs. 14 and 19) unfavorable conditions of low ground have been mainly overcome by good drainage, careful attention to the removal of débris, and the use of concrete foundations well off the ground. A description of the foundations and their cost may be of interest.

FIG. 14.—General view of a mill yard in Mississippi, showing concrete pile foundations and tramway footings. The ditch assists materially in draining the yard. No débris is allowed to accumulate. The stacks are high off the ground and amply ventilated beneath. The tramway and pile foundation timbers would be improved by a preservative treatment with creosote.

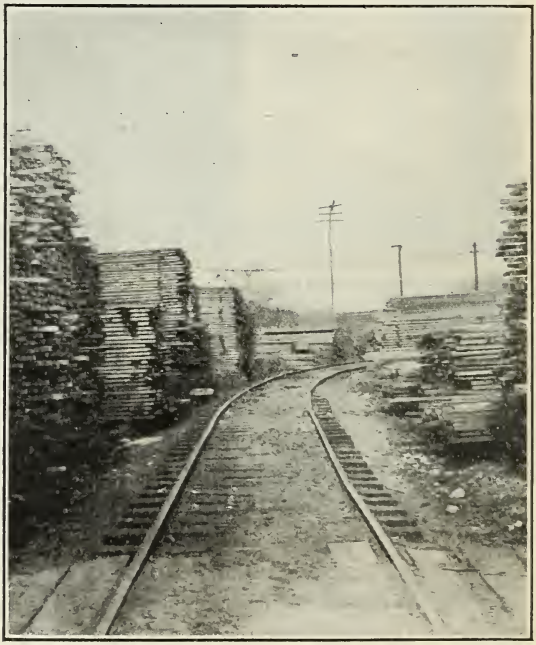
In very few lumberyards are the railway ties preserved in any way. In most cases they consist of inferior timber which readily decays. Many fruit bodies of dangerous fungi are usually present (Pl. III, fig. 2), so that it is important from the standpoint of sanitation to remove this source of infection by the application of wood preservatives, such as creosote or zinc chlorid. A track in which the ties are creosoted is shown in figure 15.

FIG. 15.—A clean, sanitary retail yard, having concrete foundations throughout and creosoted ties in the railroad track.

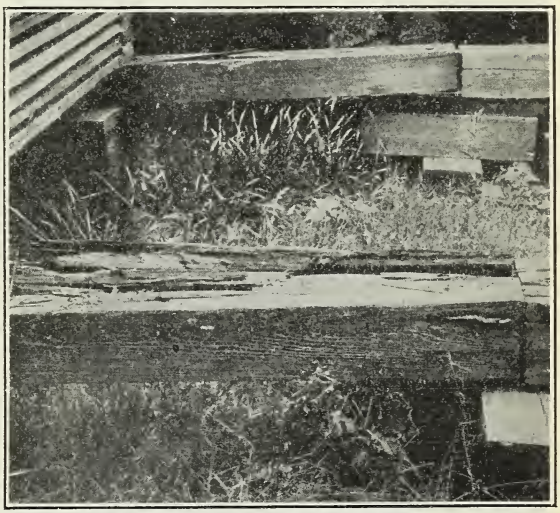
Probably no other factor involved in the storage of lumber in yards is open to more criticism from the sanitation standpoint than the foundations to the piles (figs. 16 and 34). Almost invariably these timbers are severely infected and often abundantly supplied with sporulating fruit bodies of serious wood-rotting fungi (Pl. III, figs. 3 and 4).

Various types of foundations are in use. The most primitive and most insanitary type consists in laying planks directly on the ground and stacking the lumber upon them. This procedure occurs at only a few of the smaller mills. A few of the mills make use of built-up plank foundations (Pl. III, fig. 3), but the more usual method is to use 6 by 8 or 8 by 10 stringers, blocked up to a height of

1 to 2 feet (fig. 16) or set on short posts. A few of the best mills make use of concrete piers for this purpose. The latter type of foundation would be greatly improved by the use of stringers treated with a wood preservative.

FIG. 16.—Thoroughly rotted pine skids in a mill yard in Texas. Such decayed foundation timbers are very common. Fungous infection can pass directly from these timbers to the lumber piled on them. Creosote would have prevented this condition.

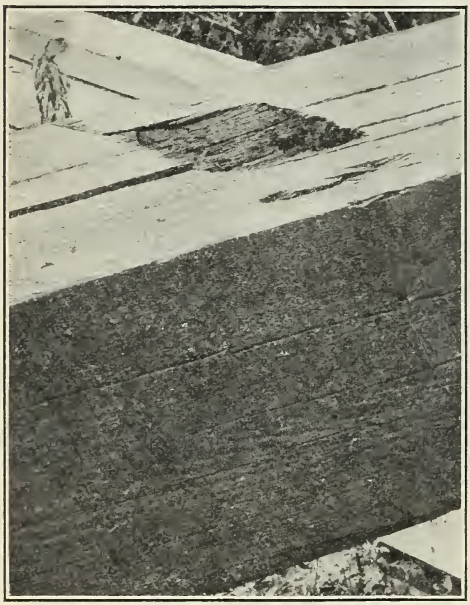
FIG. 17.—A 12 by 12 inch hard-pine timber, showing a rotten hole in the face which lay in contact with infected skids.

FIG. 34.—Built-up pine foundations in a retail yard in Tennessee. Many of the foundation timbers are seriously decayed and infection may pass to timbers piled in contact with them. Figure 17 shows what happened to a structural timber placed on a foundation in this yard similar to these.

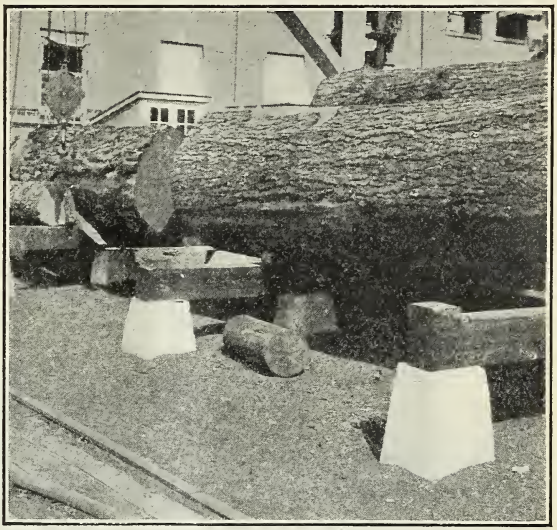
The most desirable practice, and one which would be free from all objections, is the use of concrete or brick piers, preferably the former, and skid timbers treated with some preservative. Such skids, about 24 inches high, treated with creosote, are now in use at the Forest Products Laboratory (fig. 18).

FIG. 18.—Pile foundations consisting of creosoted timbers resting on concrete piers in use at the Forest Products Laboratory, Madison, Wis. This is a very satisfactory type of foundation.

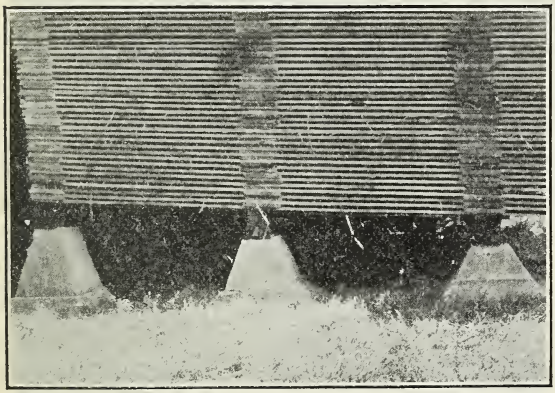
FIG. 19.—Concrete foundations with untreated skid timbers in general use in a mill yard at Laurel, Miss. Only two rows of piers are used for stock 14 feet or less in length.

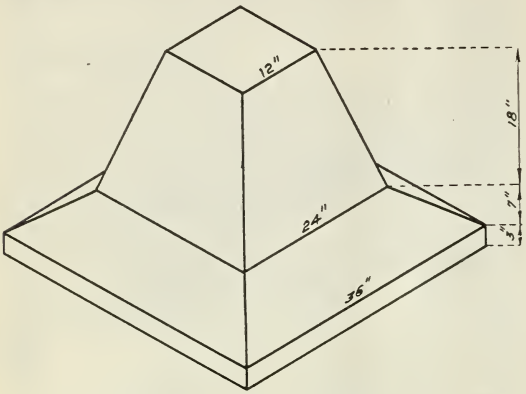
The approved type of concrete foundation pier now in use by this company is of the form illustrated in figure 20, consisting of a base block 3 feet square, tapering upward and cast in position. Upon this base block is cast the top block, 2 feet square and also taper-

FIG. 20.—Sketch of a concrete foundation pier in use in a mill yard in Mississippi. It is cast in two sections, for convenience in aligning and moving about the yard.

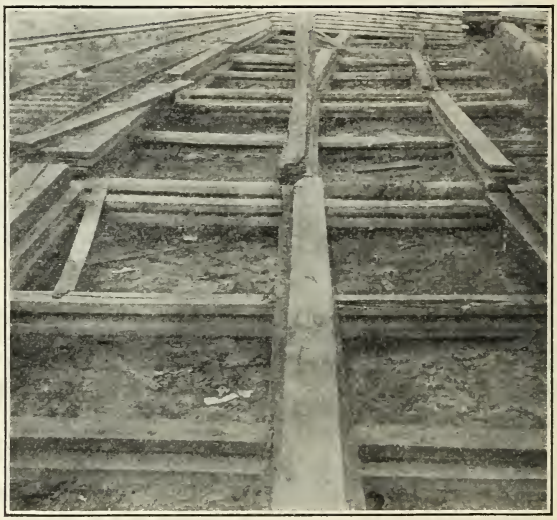
In direct contrast to these concrete foundations with ample ventilation beneath, one frequently meets with the type illustrated in figure 21. The one figured is built of 2-inch pecky cypress planks about 14 feet long, resting directly on the ground. The amount of lumber used was computed for one of the squares and totaled approximately 585 feet b. m. While pecky cypress is often used in the South for foundations of this type, in many other cases either non-

durable hardwoods or the cheaper grades of pine are used. Decay is often serious in such foundations. There is very little chance for ventilation, and this often leads to storage rots in the base of the piles.

FIG. 21.—Pecky cypress foundations in use at a mill in South Carolina. Each large square contains from 500 to 600 board feet. This type of construction does not allow sufficient ventilation beneath the piles.

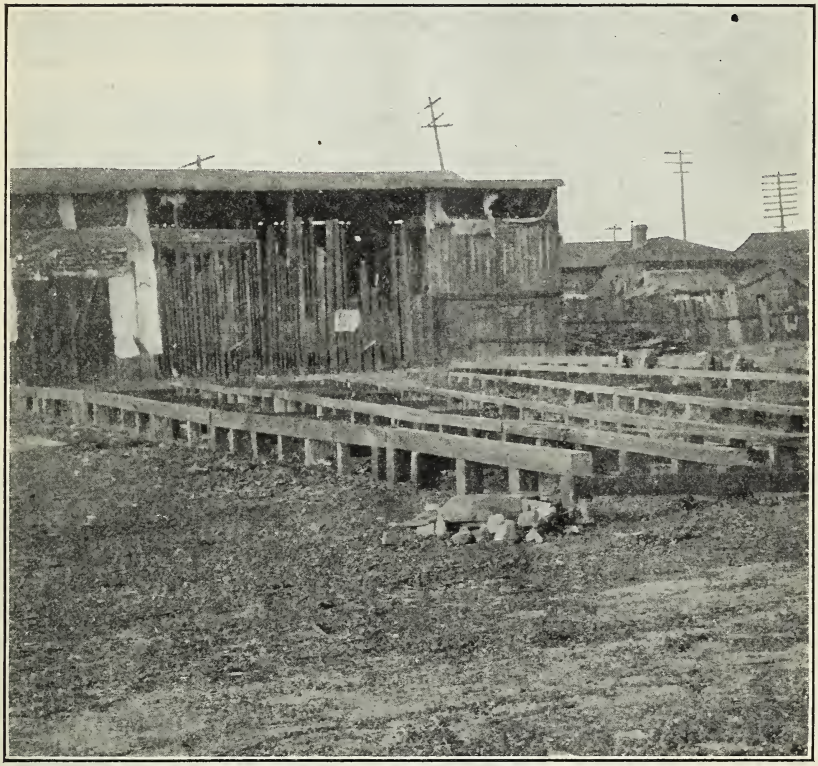
The open type of foundation is always much the better from a pathological standpoint. In certain of the Gulf cities, where municipalities in cooperation with the United States Public Health Service are making strong efforts to get rid of rats to safeguard against the bubonic plague, certain ordinances have been passed requiring structures to be raised at least 12 inches from the ground and left open beneath. This requirement will react very favorably upon lumber storage, for the first necessity is to get the timber off the ground, with ample ventilation beneath. Figure 22 illustrates the method of elevating the skids employed in a retail lumberyard at Mobile, Ala., which has only recently occupied the premises.

FIG. 22.—Foundations at Mobile, Ala., built to conform to an ordinance requiring all structures to be raised at least 12 inches off the ground and left open underneath.

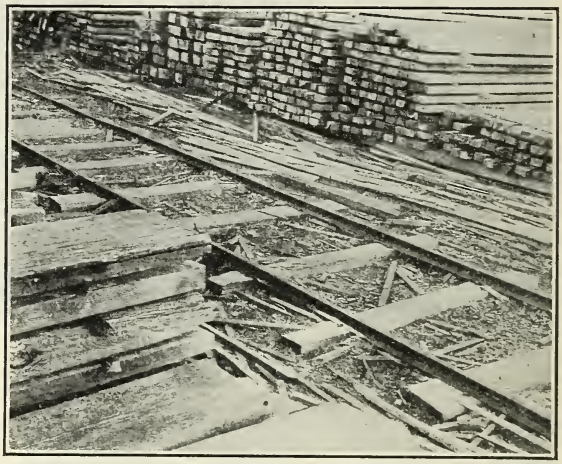
Practically all yards in which the lumber is "stuck" fail to appreciate the necessity of keeping the sticks free from infection. The strong tendency is to scatter them about on the ground wherever they happened to fall when the previous piles were taken down (fig. 24). In a very few yards attempts are made to improve the appearance of the premises by gathering the sticks endwise into conical piles or by stacking them carefully on the ground beneath the skids (fig. 25).

FIG. 24.—Piling sticks lying on the ground at a mill in South Carolina, showing the insanitary method of handling them. Such sticks lying for only a week or two in contact with fungus-infected ground may themselves become seriously infected, and decay may in turn pass on to the lumber stacks.

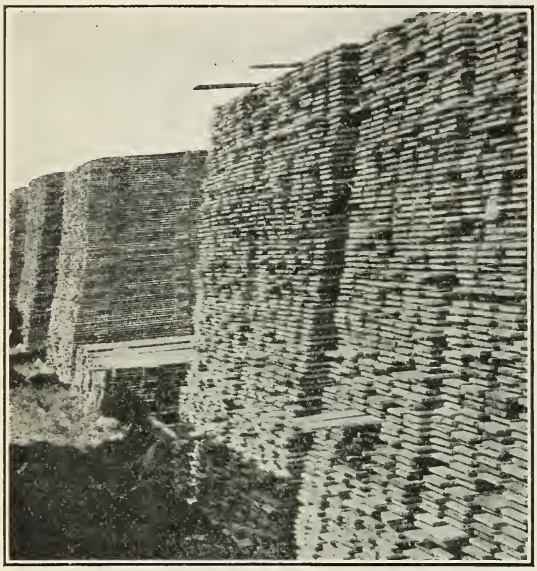
The second general method of piling lumber consists in using the narrower widths of the lumber itself for crossing strips (fig. 26). The wider boards ordinarily offer too much of a bearing surface for good air circulation. At one of the Arkansas mills visited it was customary in the earlier days to use the regular run of lumber up to 12 inches wide as crossers, but this practice was discontinued on account of the serious loss from decay. The manager of the mill informed the writer that considerable rot would occur in 8 to 12 inch stock

FIG. 26.—Lumber piled in even lengths in a southern mill yard. The crossing strips consist of the narrower widths of lumber.

Another factor which enters into the storage of lumber is the piling of stock in even or approximately uniform lengths (see fig. 26). A few mills consider that such preliminary sorting is feasible from an economic standpoint, on account of the greater facility with which such stock can be billed out. From a pathological standpoint the practice is highly commendable. Uneven lengths allow rains to beat in, and also offer convenient and favorable lodging places for fungous spores. Likewise, marked disparities in length permit considerable warping of the ends, which often project out several feet from the main body of the pile. Figure 29 shows this condition in an exaggerated form. To protect the ends of the lumber from beating rains as far as possible, the cross strips should be placed at least flush with the ends, both in front and behind.

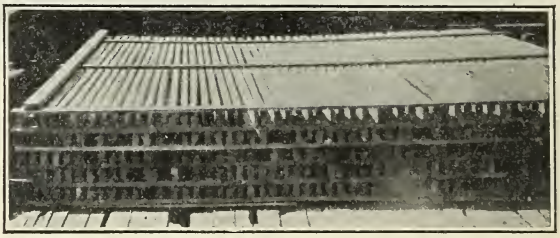
Two other methods of piling 2 to 3 inch stock are used to some extent with good results. The edge piling of 2 by 4's (fig. 27), sticking the pieces in the usual way, has given good results at several mills where flat piling produced an appreciable amount of deterioration. The method of flat piling without the use of sticks, occasionally employed with 2 by 6's, in which horizontal circulation is provided for by leaving wide spaces between the edges of the stock (fig. 28), would not appear to offer as good opportunities for drying lumber in a moist climate as the more usual method which makes use of sticks.

FIG. 27.—Edge-piled 2 by 4 pine at an Arkansas mill. This method of piling permits better vertical air circulation and consequently more rapid drying and less danger from decay during storage.

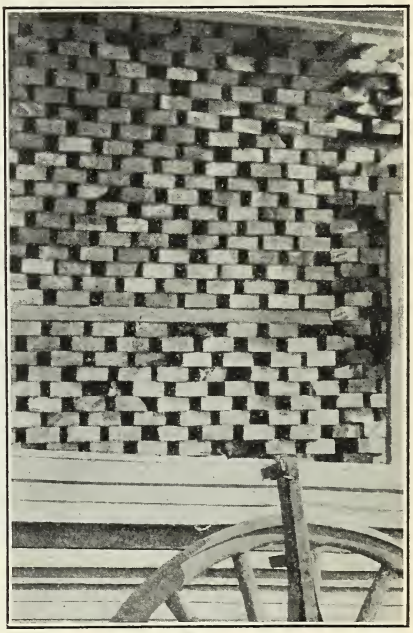
FIG. 28. — Two-inch stock piled without sticks, a method rarely used in the yards visited. Not used, as far as observed, with stock less than 6 inches wide.

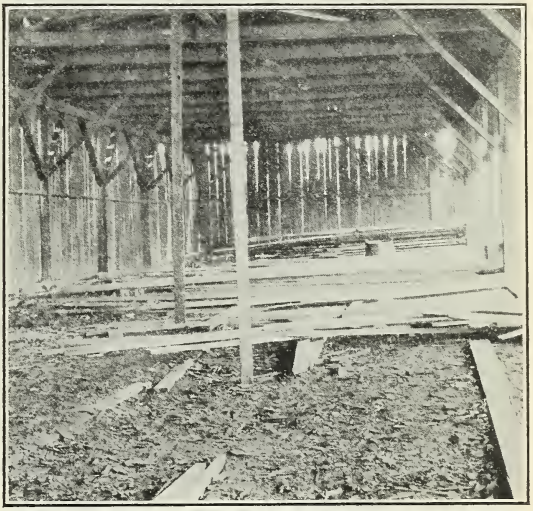
FIG. 30.—An old, dilapidated shed on the Mobile River in which the lumber is too close to the ground. Many severe cases of rot have developed under just such conditions.

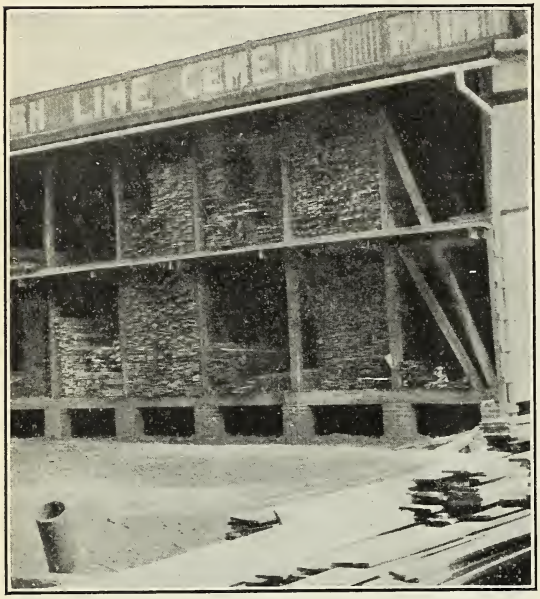
In many retail yards shed conditions are very poor. The closed type of shed is in the minority. Since lumber under cover is as a rule piled closely in bins, the need for ample ventilation beneath and a tight roof above is imperative. All the decay observed in lumber sheds is directly traceable to one or the other of these factors; mainly, however, that of improper ventilation. It has frequently been the custom merely to lay a narrow timber sill directly on the ground, or at best within a very few inches of it, to serve for the foundation (fig. 30). The best practice, however, has been to place the sills on brick or concrete piers not less than 18 to 24 inches high, running the siding of the shed only to the bottom of the sills, so as to allow a free circulation of air regardless of the direction of the wind. Such a construction is represented in figure 31.

beyond the eaves (fig. 32). Very few sheds are equipped with gutters (fig. 31), and the drip during rains may run back along the projecting pieces well into the center of the piles. When once wetted the close piles will retain this moisture for long periods, during which a serious outbreak of decay may be initiated.

FIG. 31.—A retail shed in Tennessee, well roofed, provided with gutters, and set on brick piers with ample ventilation beneath from all sides.

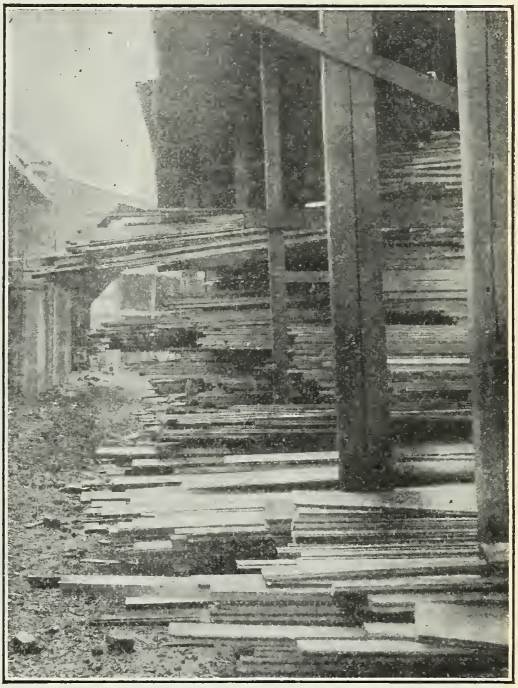
FIG. 32.—A retail shed in Alabama in which the lumber projects beyond the eaves, thus catching the drip from rains. This condition favors decay when the water runs back along the boards into the piles.

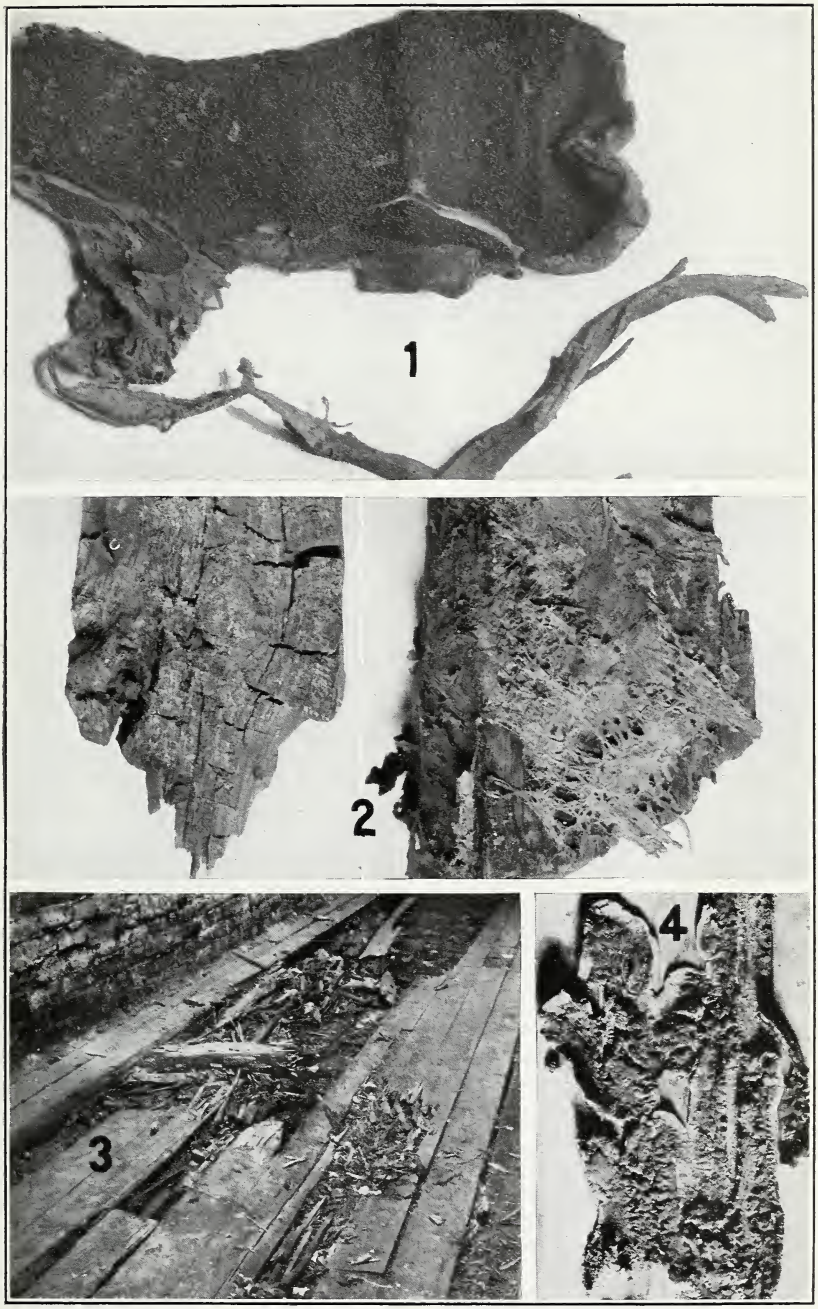
LUMBER SANITATION: WOOD-ROTTING FUNGI.—IX.

FIGS. 1 and 2.—*Merulius lachrymans:* 1, A well-developed fruit body with porous moisture-conducting strand (from a residence in Pennsylvania); 2, mycelium growing over the surface of the rotten wood. FIGS. 3 and 4.—An unidentified fungus in a Mississippi cotton warehouse; 3, flooring rotted by the organism; 4, fruit bodies developing on other parts of the floor. (This is the same species illustrated in Plate X, figures 1 and 2.)

Merulius lachrymans (Pl. II, figs. 1, 2, and 6, and Pl. IX, figs. 1 and 2) is a soft, subgelatinous fungus, forming a brown, crumpled growth with a white, fluffy margin over the surface of timber. As it develops it produces dirty gray to brownish minutely porous strands, which serve for the conduction of water, thus enabling the fungus to spread rapidly over comparatively dry substrata. For this reason it has been frequently termed the "dry-rot fungus." On account of its destructiveness to buildings in Europe it also goes under the German name "Hausschwamm." It rots coniferous timber for the most part.

laid on flat 2 by 6's resting on ashes was very quickly rotted out by this same fungus (Pl. IX, figs. 3 and 4), likewise offers circumstantial evidence.

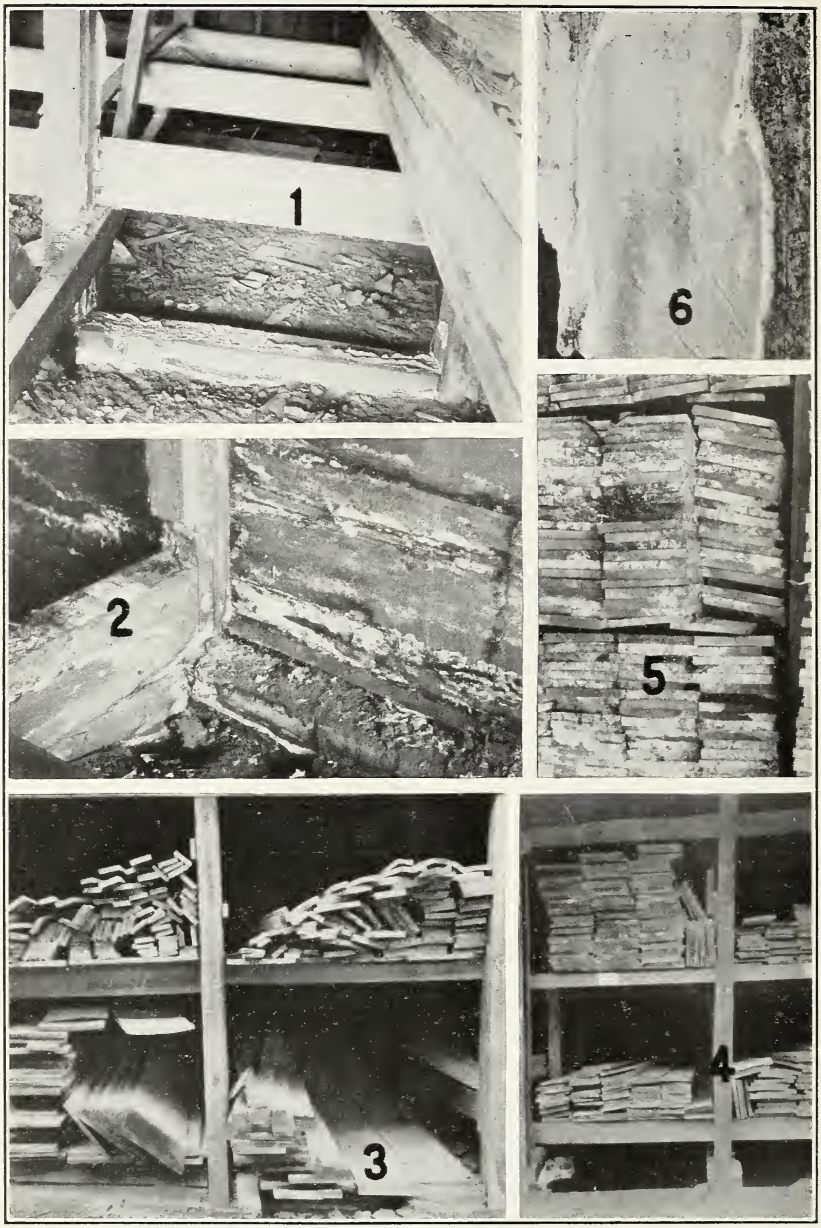
LUMBER SANITATION: WOOD-ROTTING FUNGI.—X.

FIGS. 1 to 4.—A severe infection of an unidentified fungus in an Alabama lumber yard: 1, Open shed where the fungus has progressed upward to the second bin, 5 feet from the ground; 2, corner of closed shed on the same premises where rolls of tarred roofing paper resting on the floor (not shown in the picture) were severely rotted at the ends; 3, the shed shown in figure 1, showing how the infection started by piling too close to the ground over a cinder fill; 4, the same shed after the lower bins had been raised in an effort to control the spread of the rot. FIGS. 5 and 6.—*Peniophora gigantea:* 5, Intermixed with molds and developing on moist pine shingles in a close pile in a Tennessee retail yard (growth, which an antiseptic dip at the mill would have prevented, had started during transit); 6, the mature stage growing on a pine log.

Besides *Merulius lachrymans* and *Coniophora cerebella* the writer has twice encountered another organism of much the same habit of growth and destructiveness. This organism, the identity of which has not yet been determined, was first found in a retail lumberyard in Alabama and later in a cotton warehouse in Mississippi. The owner of the lumberyard had appealed to the writer for assistance in eradicating a very serious infection, so a careful inspection was made at the first opportunity and the organism was found in great abundance in all three of the open storage sheds, where it had destroyed many of the foundation timbers and also passed upward into the stored lumber (Pl. X, figs. 1–4). The first serious infection noted in this yard occurred six years ago, when two carloads of 6 by 6 pine timbers piled in the open yard were so badly decayed to a height of 6 to 8 feet in the piles as to be rendered useless for building purposes. This material was at once disposed of for firewood. Three years later a further outbreak occurred in two of the open storage sheds and in an addition attached to the small office building. During 1913 a serious infection was also found in a third open shed

According to the owners, the immediate loss of this yard in stock and repairs up to October, 1914, was estimated to be between $1,000 and $2,000. This represents, however, only the actual loss to the company in lumber, figured at wholesale prices, and labor necessary in making repairs. The potential danger to the consumer using such stock, even though but very slightly infected, would amount to very much more than this sum, for a single stick introduced into each of a number of new buildings would occasion an incalculable amount of damage if such timbers happened to be placed in a moist situation favorable for the further development and spread of the fungus.

As soon as the infections were noted as serious, the company attempted eradication and control measures. In the office building the spread of the fungus has been checked by proper ventilation, and in the sheds the same methods are being applied by removing the cinder fills beneath them and raising the foundations to a height of 18 to 24 inches, placing the sills on brick piers. In future repairs the writer has suggested the application of either mercuric chlorid or some creosote compound to the new timbers.

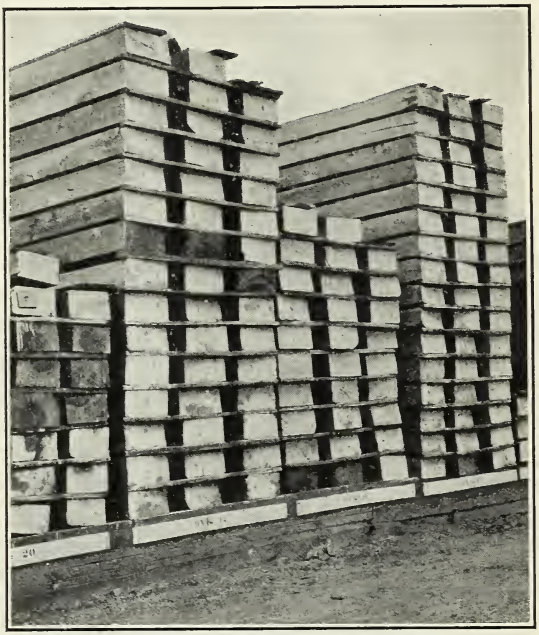
Many retail lumber yards use solid or latticed foundations of built-up plank running parallel to the alleys (figs. 36 and 37); others resort to wood blocking for the support of the skids. The use of concrete is very limited, but has given complete satisfaction wherever introduced. It is usually laid down as solid foundations parallel to the alleys. In one yard at Birmingham, Ala., the foundations were 8 to 10 inches high, 6 inches thick at the top, and placed in triple parallel rows spaced 7 feet apart (fig. 38). The advantage of reinforcing the concrete is well shown in figure 39.

FIG. 36.—The solid type of built-up plank foundation. This permits air circulation beneath the piles in only one direction. The ends of the stock have been painted to prevent checking.

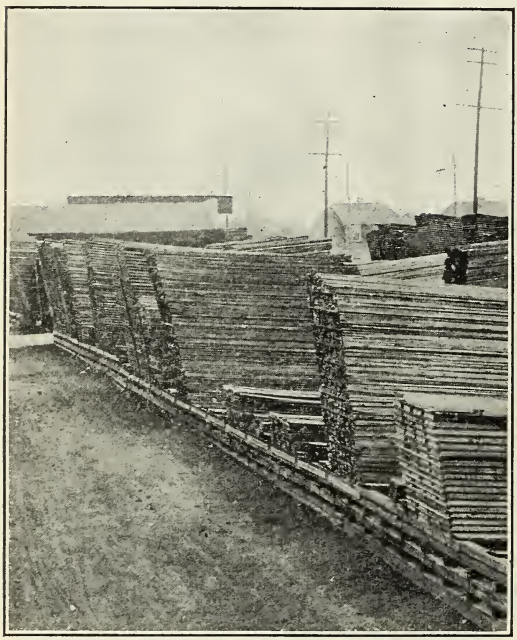
FIG. 37.—The latticed type of built-up plank foundations. This is an improvement over the solid type, as it allows better ventilation beneath the piles.

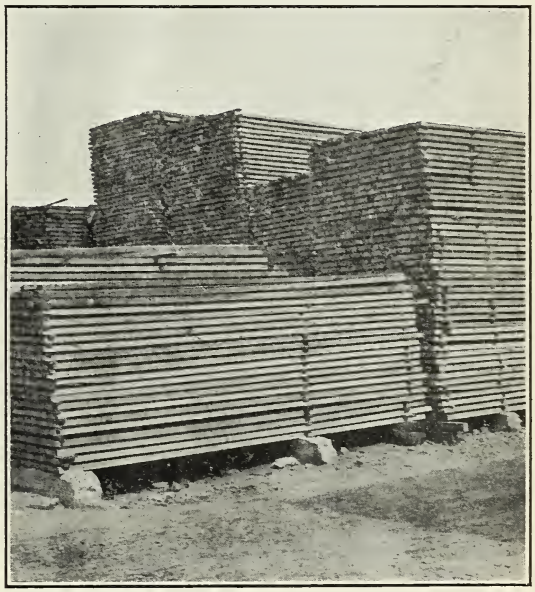
FIG. 38.—Concrete foundations in the retail yard in Alabama shown in figure 15.

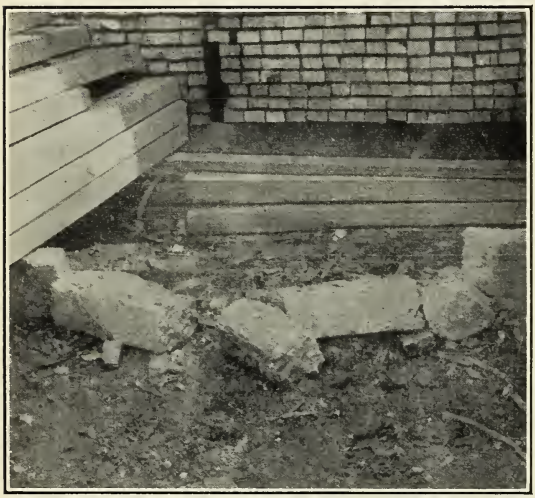
FIG. 39.—Broken foundations, a result brought about by not reinforcing the concrete. The company later embedded some old 20-pound steel rails in the concrete near the top.

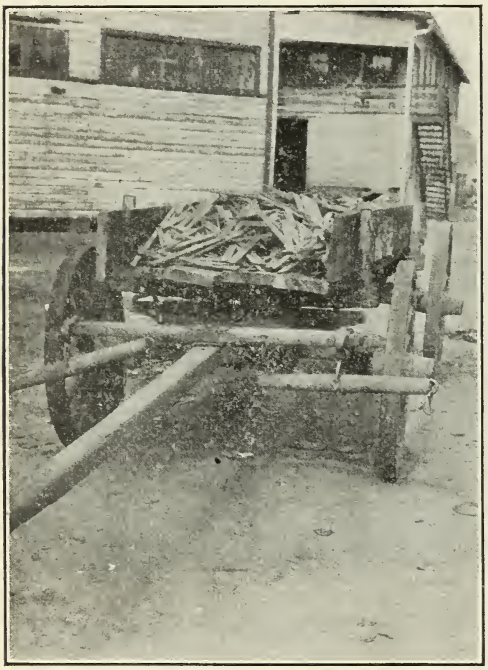
The careless handling of crossing sticks and lumber in retail yards is just as evident as in mill yards. The general practice in many of the yards visited is to throw sticks about on the ground when the stacks are torn down, and there they often remain until they are needed again. This insanitary practice needs no further comment. A comparison of the yard shown in figure 40, where the lumber is scattered about promiscuously on the ground, with the yard shown in figure 15, where concrete foundations and treated ties are in use and all débris is carefully collected into a wagon (fig. 41) and hauled away, may be of interest in this connection.

FIG. 41.—Wagon loaded with fragments of lumber to be hauled away. This is the highly commendable practice by which one lumber company keeps its yard clear of débris.
